Inspection of Small Dams

Publication No. T/434
Revised October 1998
ISBN: 0-7785-0633-9

Dam Safety and Water Projects Branch
Water Management Division
Alberta Environmental Protection
8th Floor, Oxbridge Place
9820-106 Street
Edmonton, Alberta
T5K 2J6

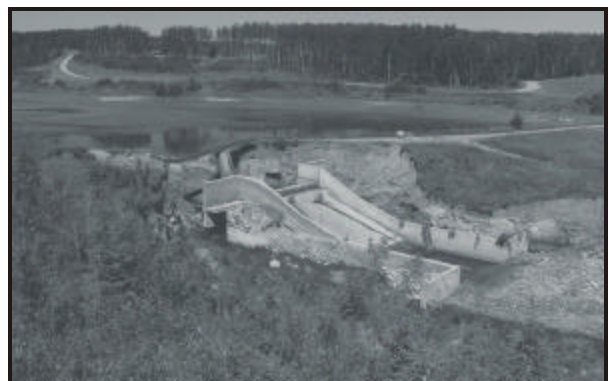
Photo No. 2 (DSB 9051-18)
Mound Red Park Reservoir July, 1990

An overtopping failure as a result of storm runoff larger the spillway capacity.

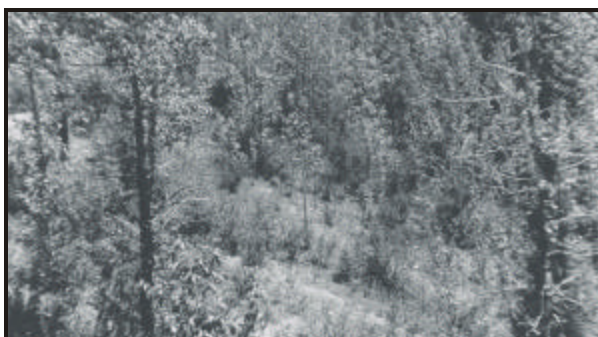
Photo No. 5 (DSB 9200-40)
Pedley Water Tank, 1976
Excessive vegetation on upstream slope.

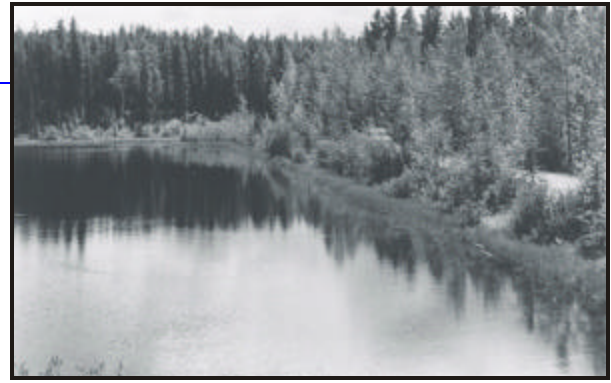
Photo No. 6 (DSB 9200-39)
Pedley Water Tank, 1976
Excessive vegetation on downstream slope.

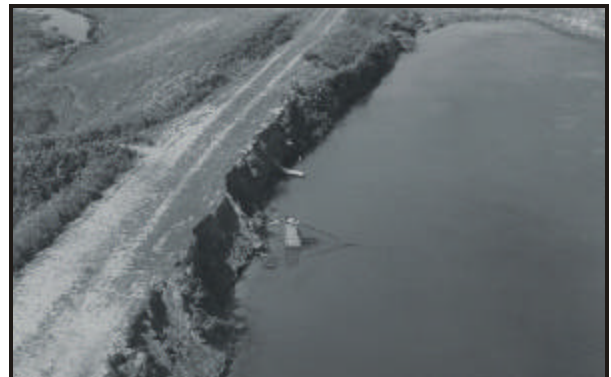
Photo No. 7 (DSB 7823-24A)
Extensive erosion of the upstream slope caused by wave action. This has displaced all the riprap, created beaching and vertical scarps, reduced crest width and left the riparian outlet control unsupported.

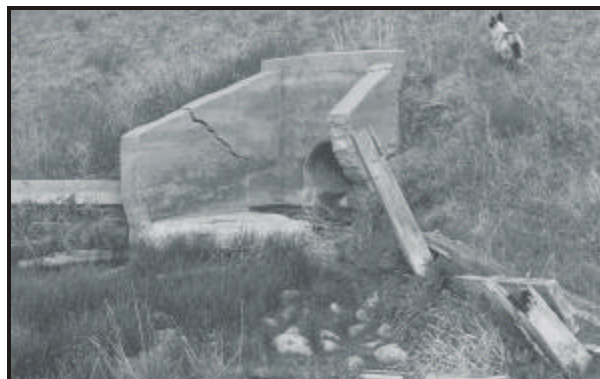
Photo No. 9 (DSB 9200-41)

Slide gate control for a low level outlet damaged by ice action

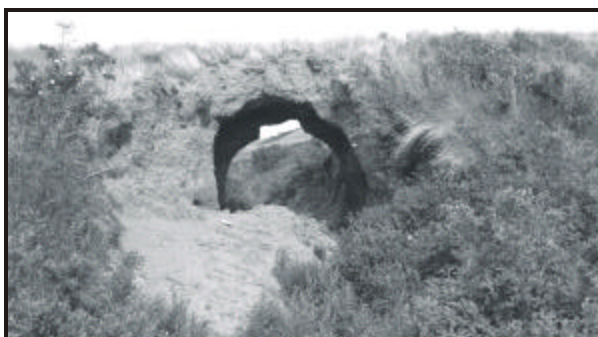
Photo No. 13 (DSB 7745-11)

A hole which developed through an embankment as a result of a piping failure.

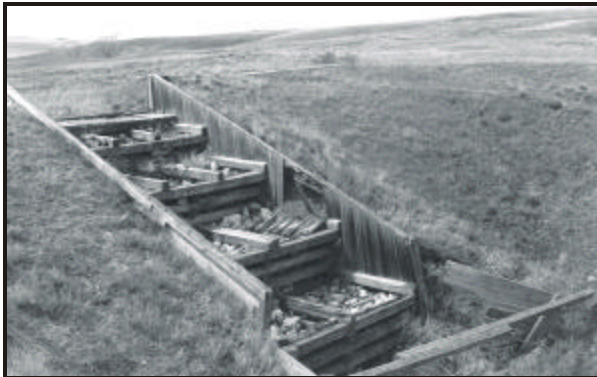
Photo No. 15 (DSB 8402-1)

A timber chute spillway in very poor condition.

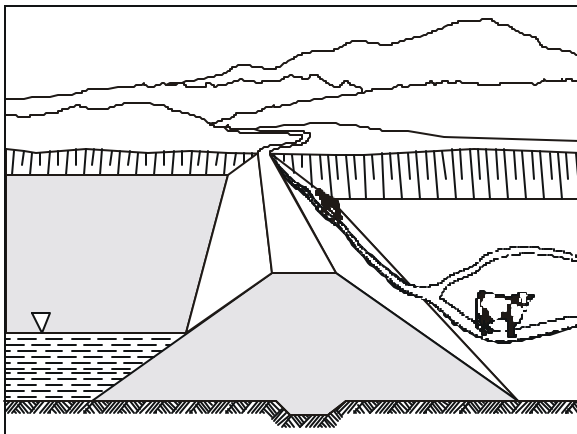
EROSION

1. Livestock traffic.
2. Surface runoff.
